# T34 World News

2014 Edition #31

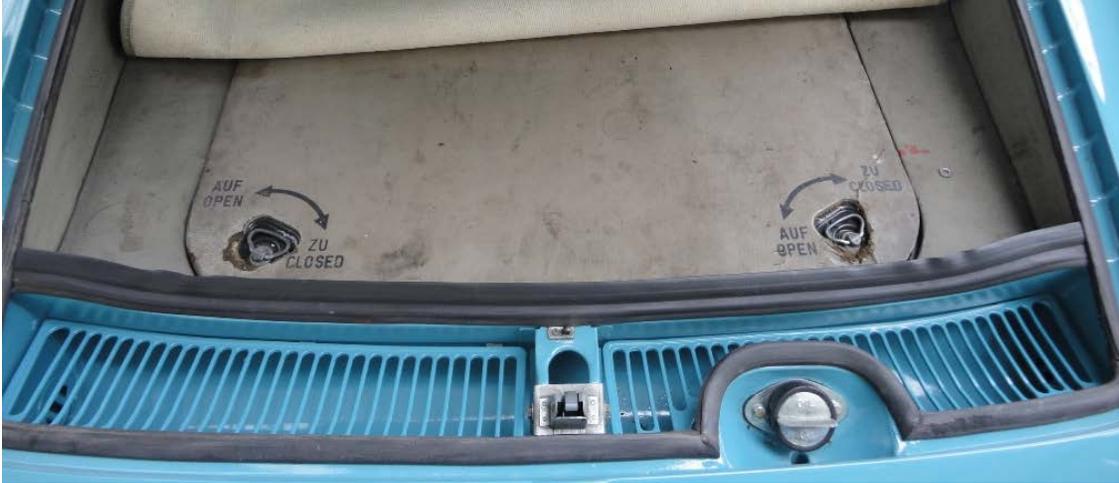
## Parts Source: Trapdoor Instructions Graphics

When you've already replaced the engine trapdoor insulation the final thing you'll be wanting is the instruction graphics. These were printed in black onto the insulation in both German & English lettering. The Auf & Zu are German for open & closed. The early models (1963-66) used O & C underneath the German letters for open & closed. The late models (1967-69) had OPEN & CLOSED spelled out (above).

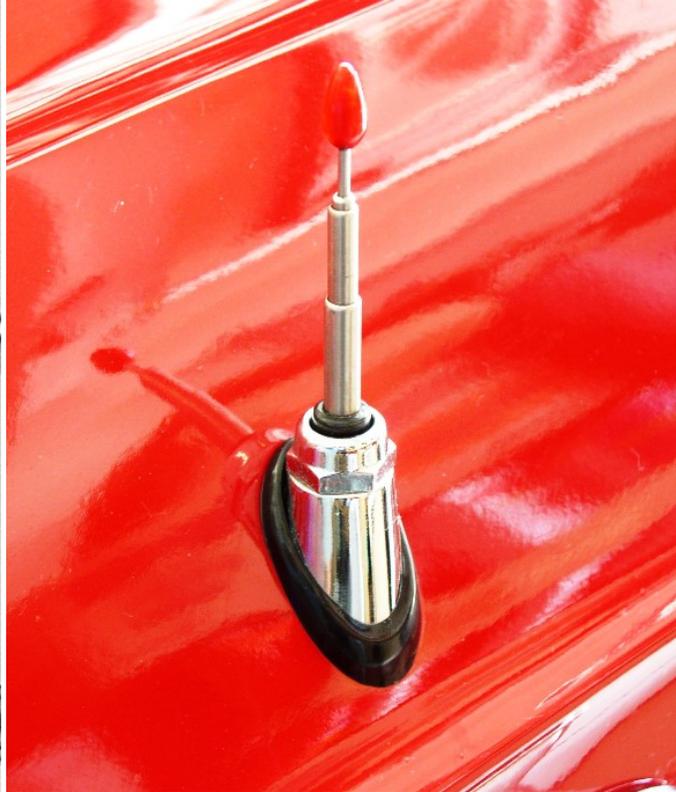
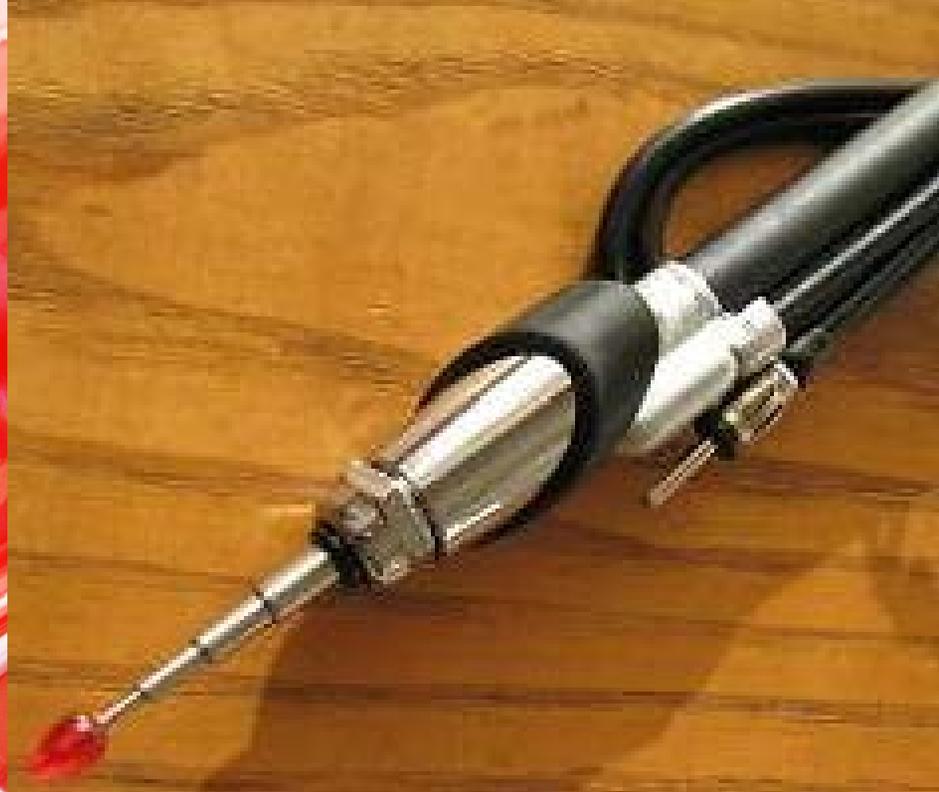
## Parts Source: Red Tip Antennas

When a T34 customer wanted a radio fitted to their car they visited the VW dealer and looked through the available radio models & chose an antenna as well. There were many radio variations but the majority of radios fitted to T34s when new were the Blaupunkt Frankfurt model. The antenna was mounted on the driver's side fender, just above the side marker light, using the paper T34 template (right center) that was provided inside the antenna packaging.

Antennas were typically manually retracting, so they could be lowered down into the body to avoid being broken or bent. The angle of the fender mount was 58 degrees and were a fixed angle design with four telescoping sections. Hirschmann & Bosch were two of the most common manufacturers. Most were made with metal tips but some had colored jeweled tips in red or blue.

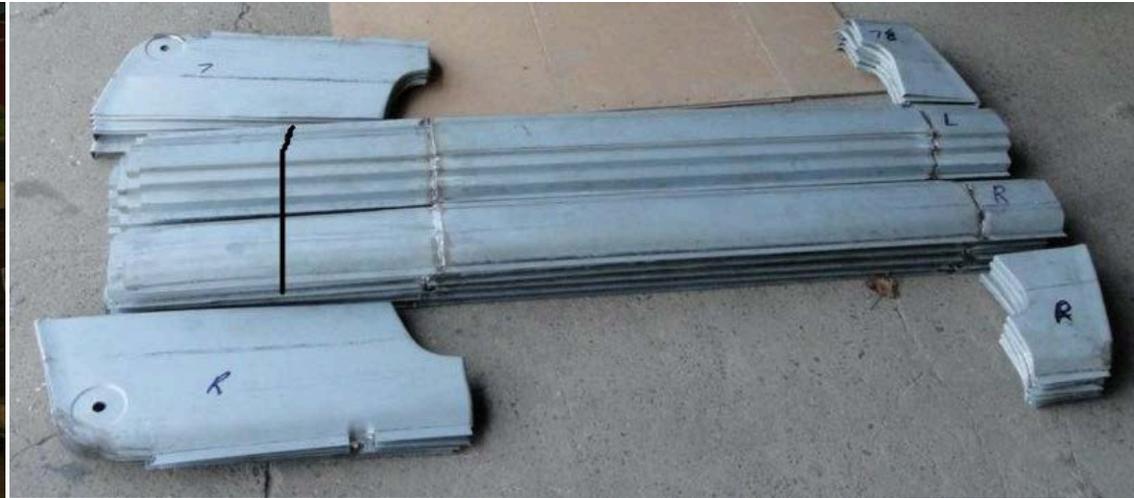
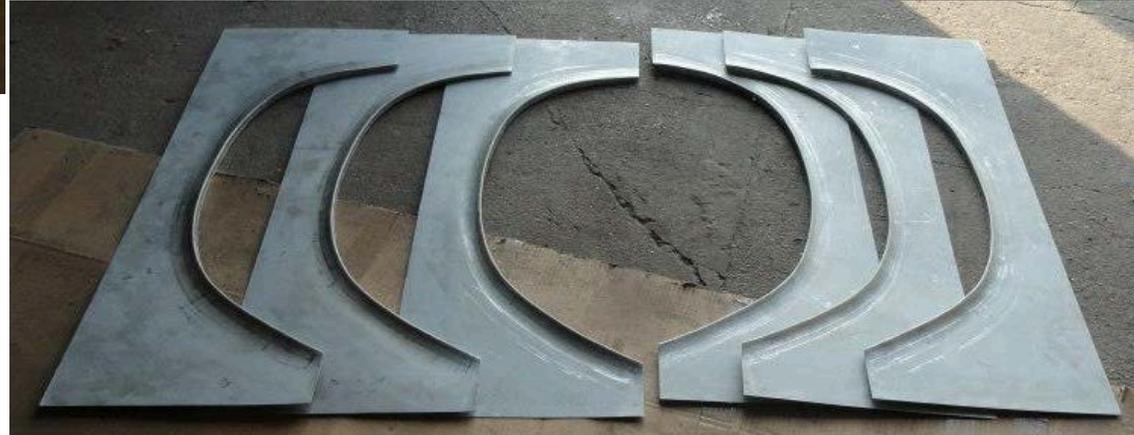
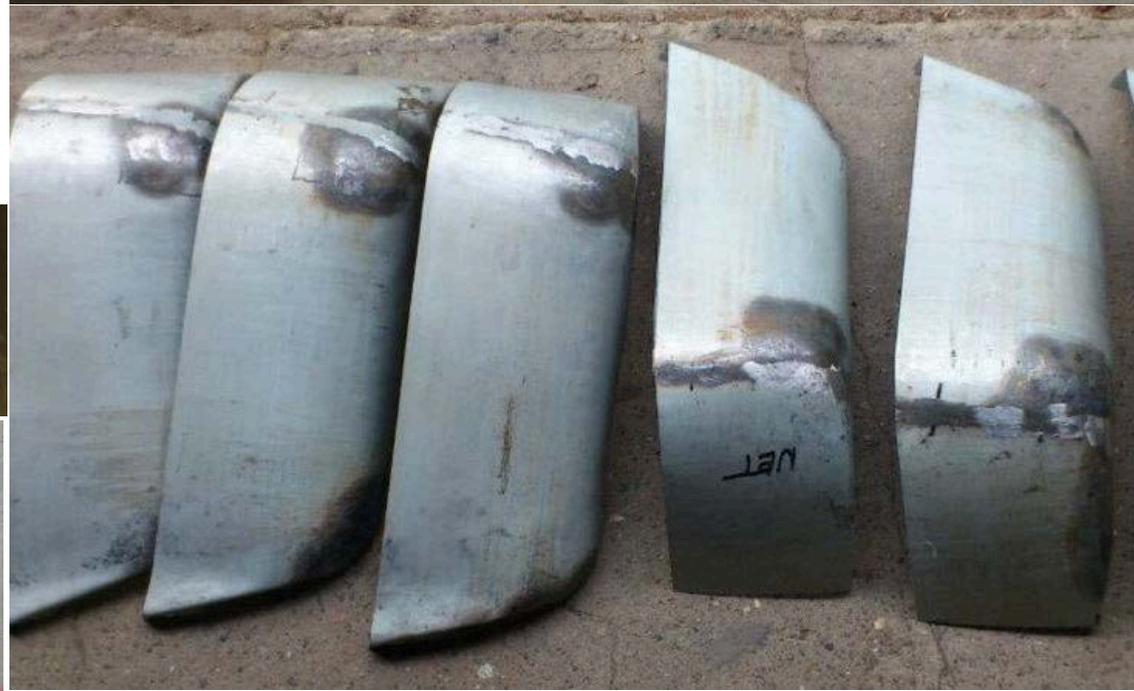
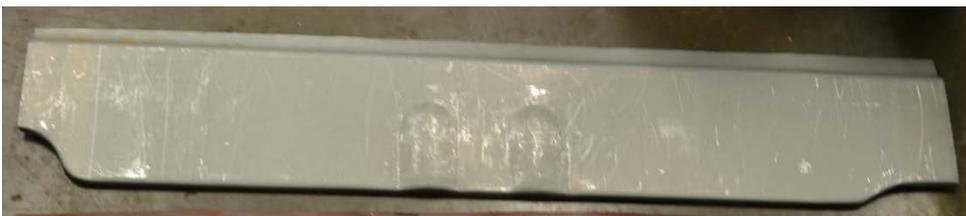
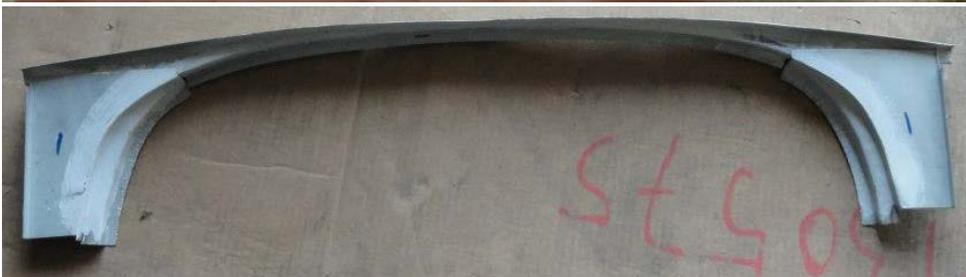
## Parts Source: Reproduction Metal Panels

Jurgen Magdelyns in Belgium has reproduced several T34 metal panels for many different areas that are commonly rusted-out. Please contact him at [JurgenMagdelyns@T34World.org](mailto:JurgenMagdelyns@T34World.org) for shipping costs to your location. He accepts PayPal for payments.

- Lower rear corners 190 Euro
- Wheel arches 190 Euro
- Rocker panels 550 Euro (six pieces)
- Lower rear apron 130 Euro
- Spare tire well surrounds

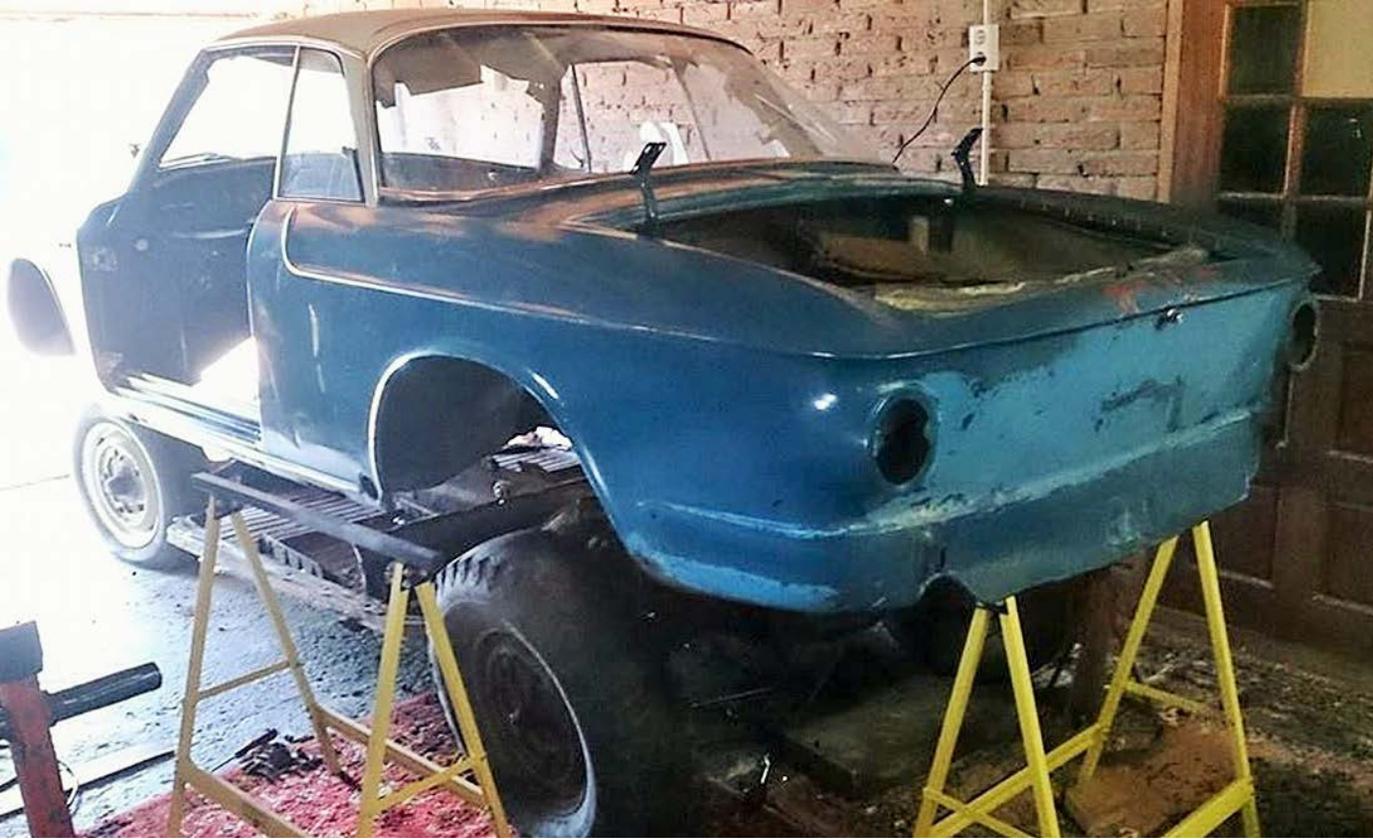
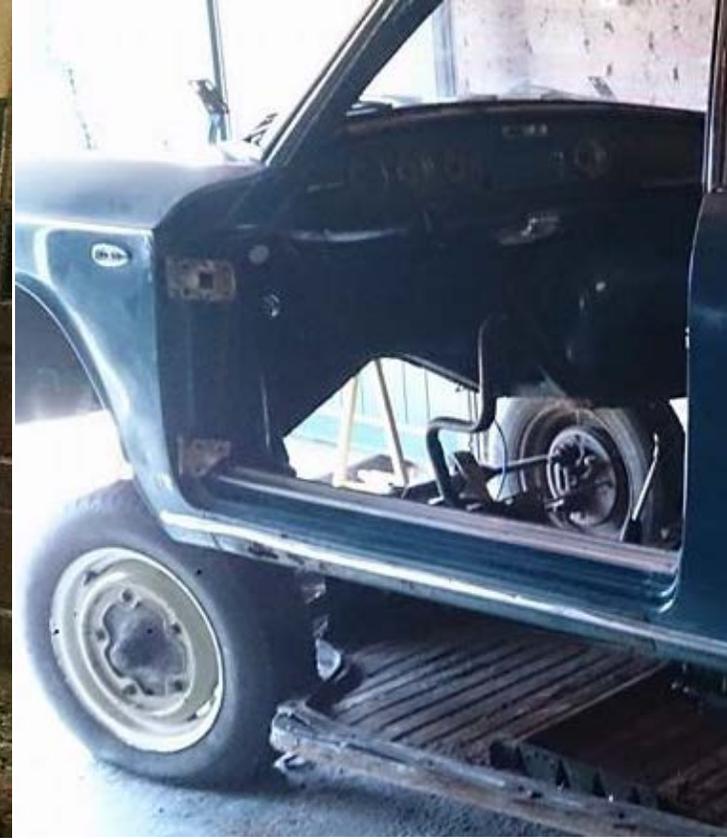
## Resto Update: Ferdi's 1964 Coupe

In Feb 2014 he decided to separate the chassis from the body so he could discover the rusty areas and repair them. Ferdi says "after a good marriage of 50 years the body & chassis are now divorced temporarily". He feels it's not going to be a 10-year project but his goal is the Spring 2015.

The chassis will be sand blasted and repaired, and will get a double coating for protection. The gearbox will be cleaned, new suspension, new copper brake lines, new brake cylinders, etc. He plans to install the original front beam, but wants dropped spindles.

He's been taking the restoration process slowly and working hard to return the T34 parts to like-new condition. You can see (top right) the level of detail that he's already put into the starter motor. So you can bet the rest of the T34 will be just as detailed when he's finished. And you can bet that Luka will be ready to cruise too!

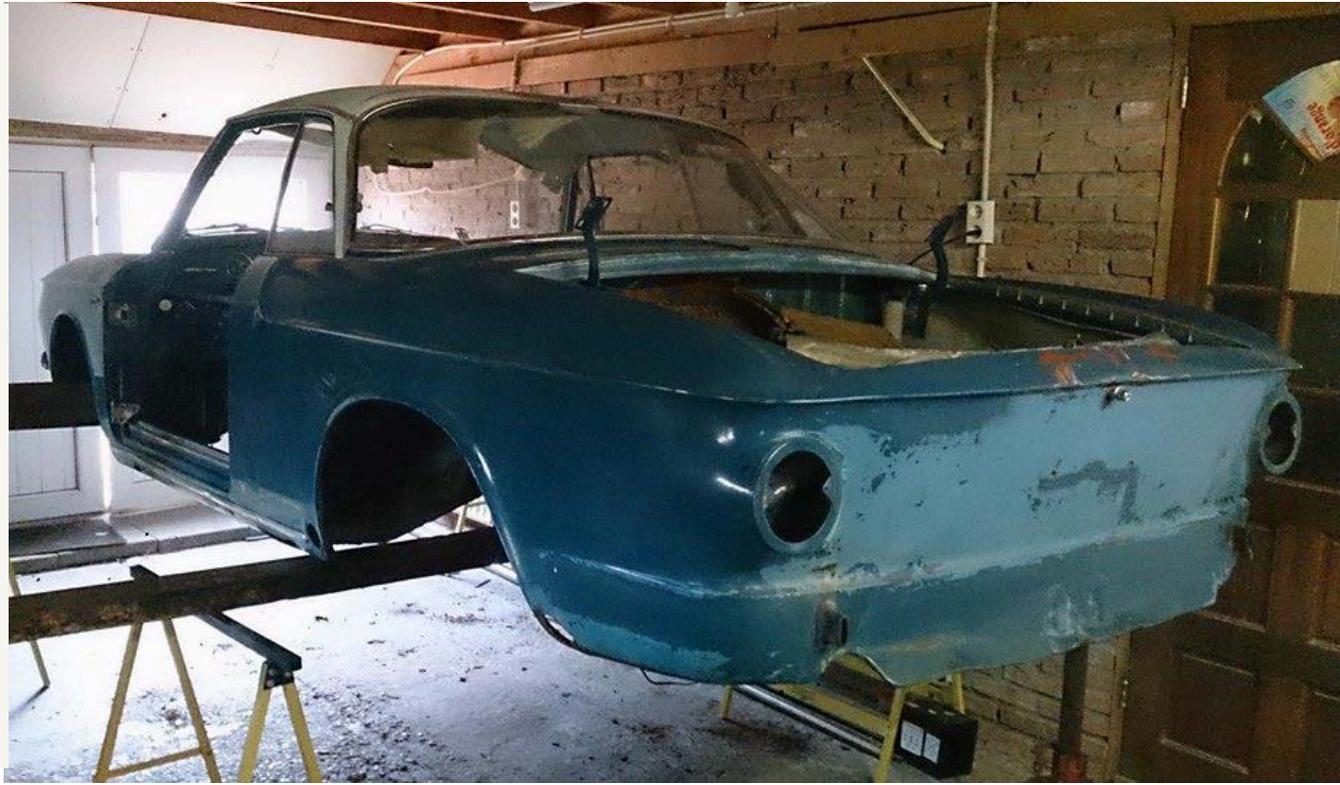
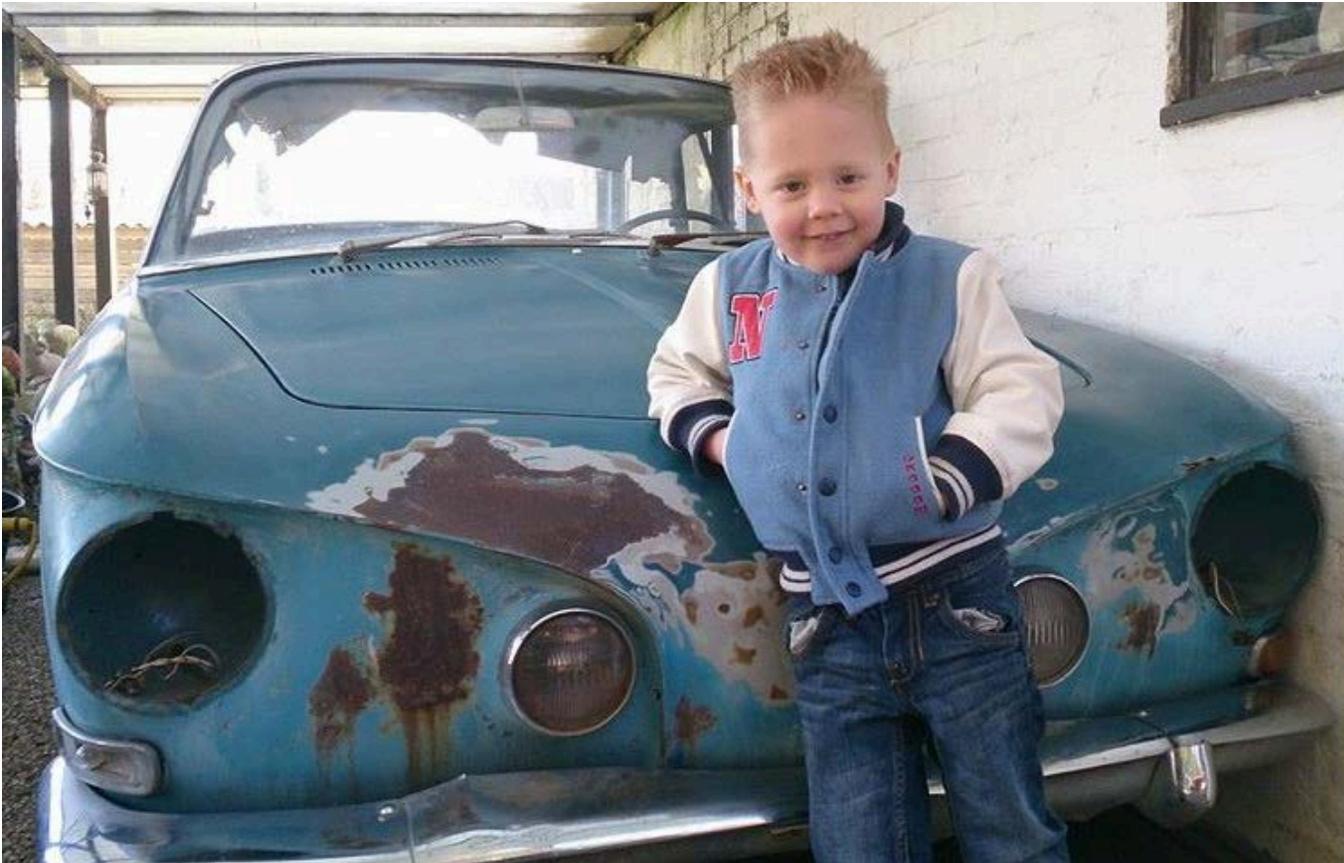
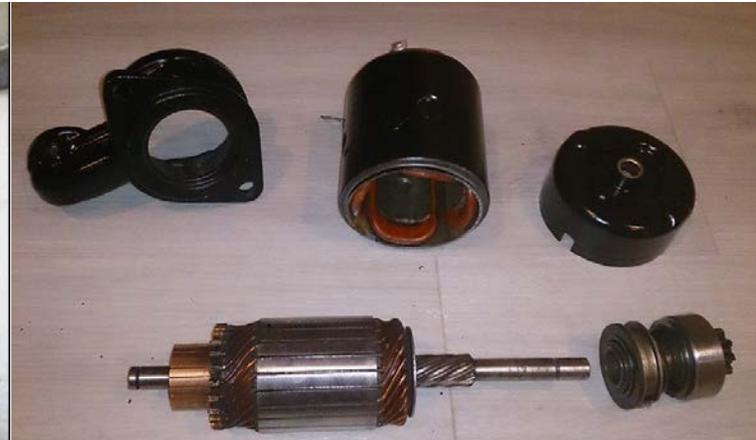
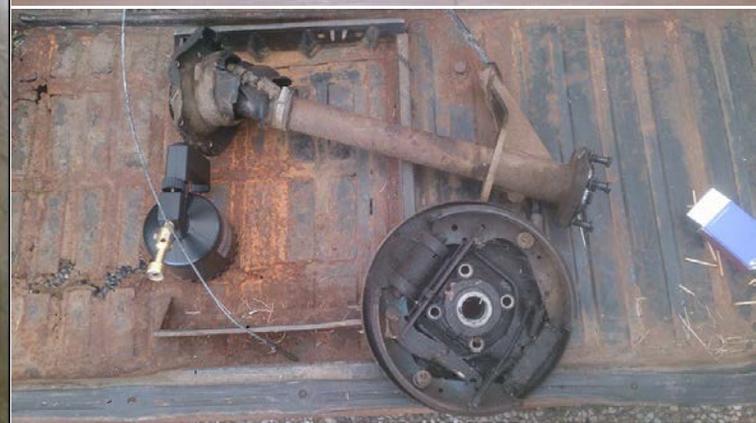
The body needs several new parts so he plans to cut out the rusty areas and weld-in new panels handmade by his brother. The biggest repairs are on the rocker panels, of course. There are five smaller holes that will be repaired. Only the parts that will be renewed will be painted to its original color. After that Ferd plans to redo the interior with new interior panels, new seat upholstery, & new carpet. He has already found the authentic Cerulean Blue cloth for the seat center sections and just needs to find the authentic Ice Blue for the outer sections.

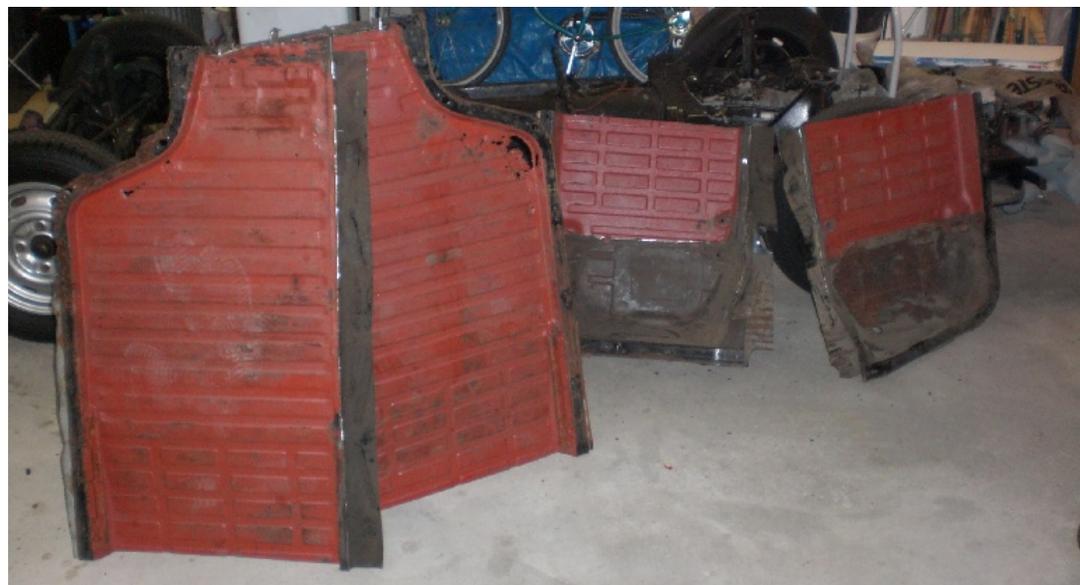
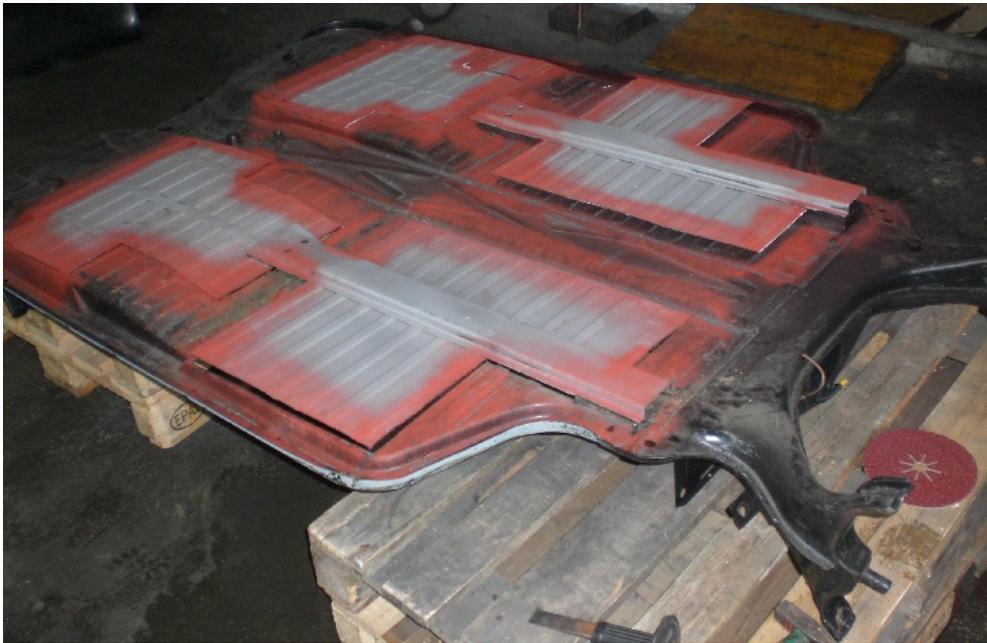
The floorpan sections were sandblasted & the naked chassis was given to body master Paul Goldinger who cut-out the rusty pieces and matched the Belgian floorpan pieces like a puzzle (above). After the welding was done the rust-free chassis was given to Guido's workshop. Guido and Philip spent many hours grinding down the welding seams (below).

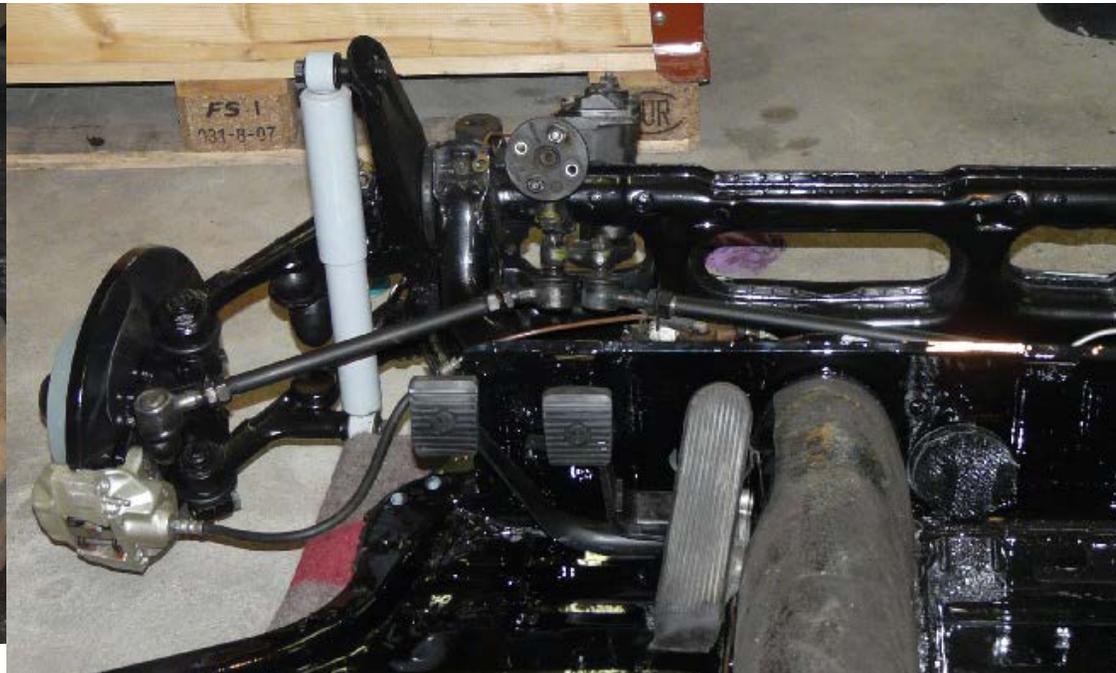
The chassis was painted gloss black in January 2009. Philip worked on cleaning the front & rear axle parts. The front beam was mounted to the chassis (above). The fresh black chassis was looking amazing!

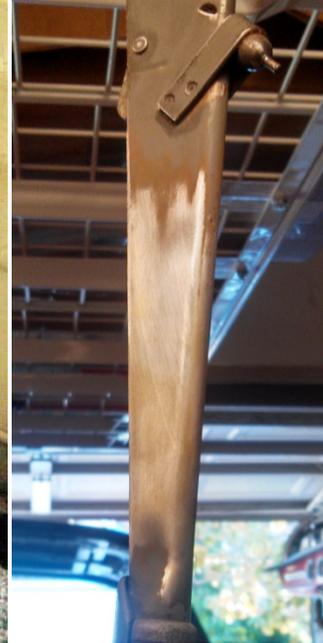
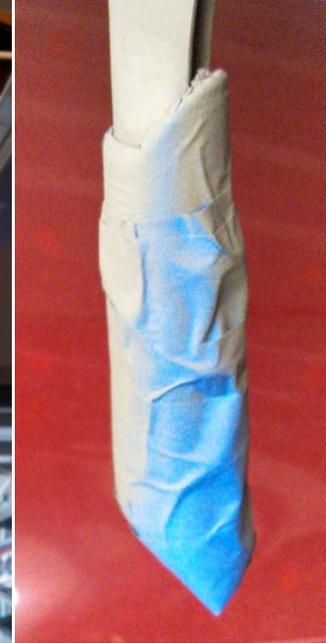
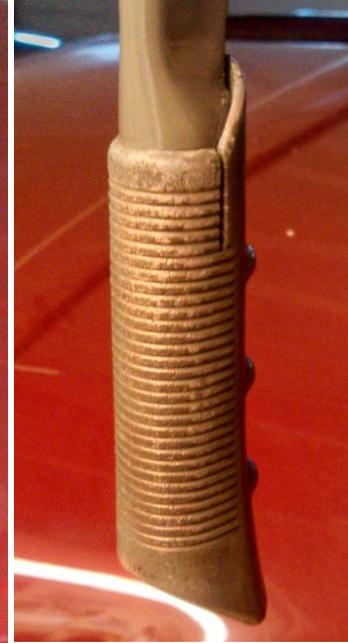
Removing the e-brake takes just a couple minutes with a 10mm wrench, flathead screwdriver, & 10mm socket wrench. Start by removing the e-brake boot over the handle, then removing the two 10mm nuts tightened against each other on each cable. There may be a flat metal balance piece connecting the two cables. Remove the C-clip attached to the driver's side end of the large pin at the base of the e-brake handle. Then use a screwdriver to push out the pin. Now the e-brake handle comes out freely. Take care to remove the metal toothed piece connected to the base so it doesn't fall inside the hole.

With the handle out, use fine sandpaper to remove what's left of the original paint. I didn't remove the plastic handgrip for fear of it disintegrating in my hands. After sanding down to bare metal along the shaft, wash well with soap, rinse really well, dry off the metal and hang it to dry. Mask the plastic handgrip with painter's tape, using an Exactoknife to trim away the tape around the handle's edges.

Apply two coats of primer and allow to dry overnight. Then apply two coats of the Anthracite spray paint from Wolfsburg West (Southern California USA) and allow to dry overnight. For a protective shine, spray one coat of clear, as the e-brake handle gets nicked by seat belt buckles & rubbed by forearms when driving.

When everything is dry remove the painter's tape & reassemble the parts. Be sure to adjust the e-brake handle so there are 4-5 clicks to fully engage the emergency brake handle.

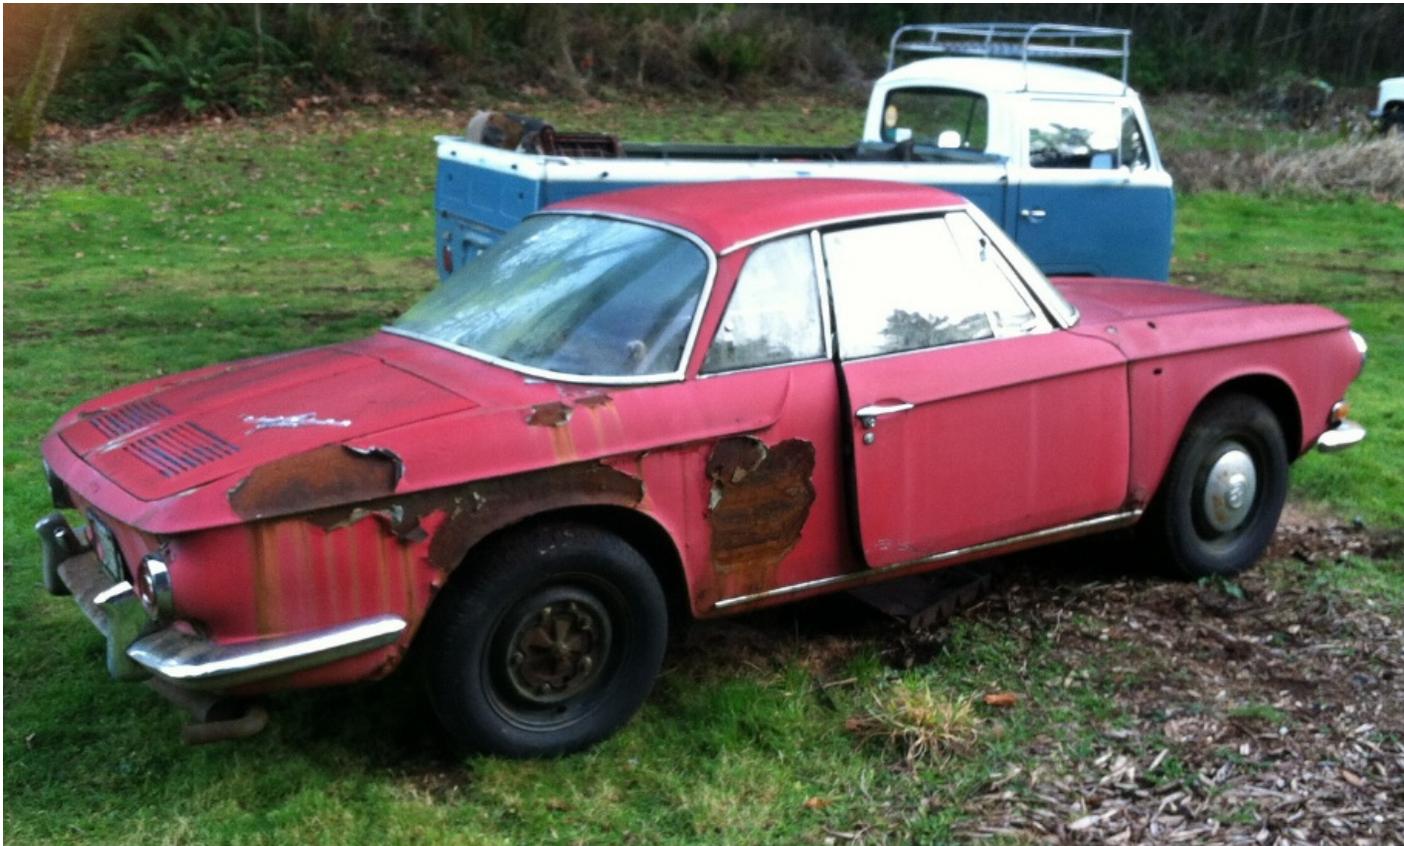
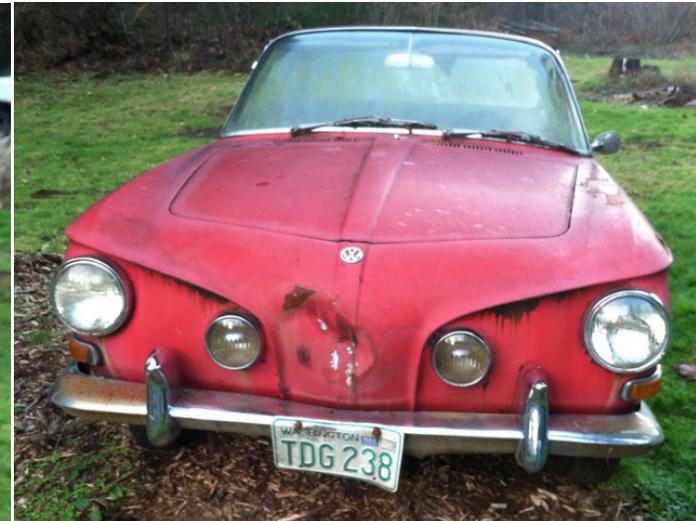
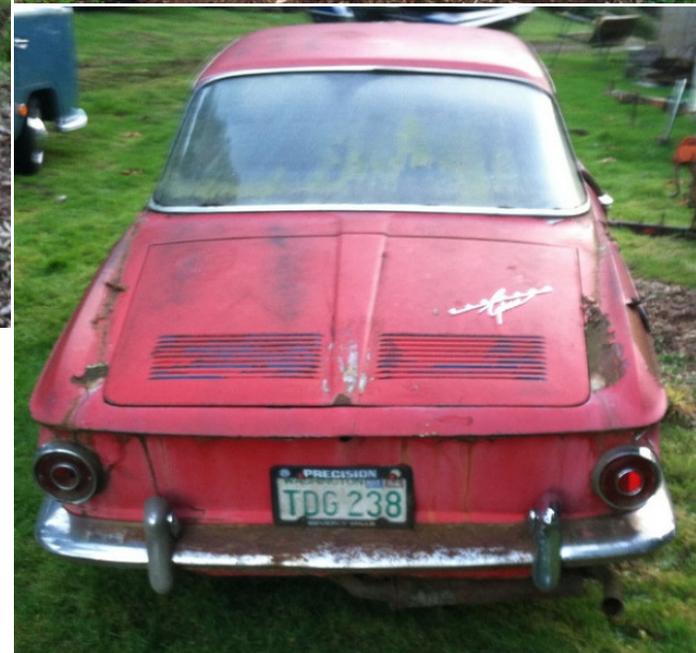
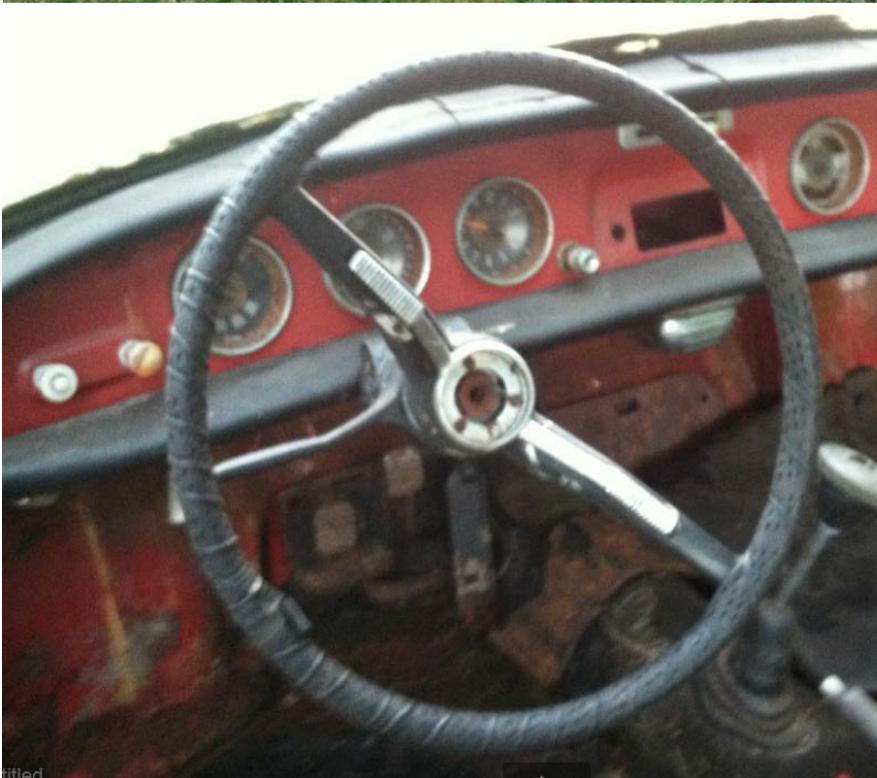
In late-2013 Mill found an abandoned 1964 T34 Coupe that had spent many years outside. Since he needed some parts for his 1965 he bought it and trailered it home. Although the body looks pretty rusty in a few places, it has the rocker trims, a nice turn signal lever, and all the lights & bumpers. The rust worm has really done a good job on the floorpans with gaping holes showing daylight.

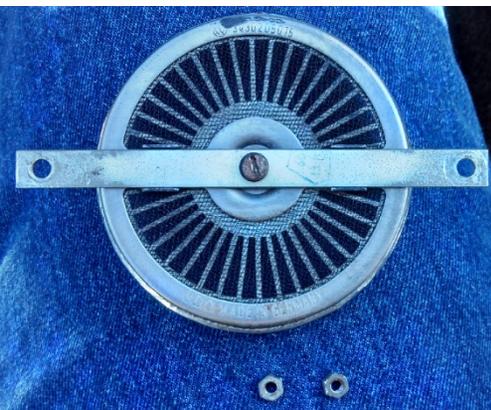
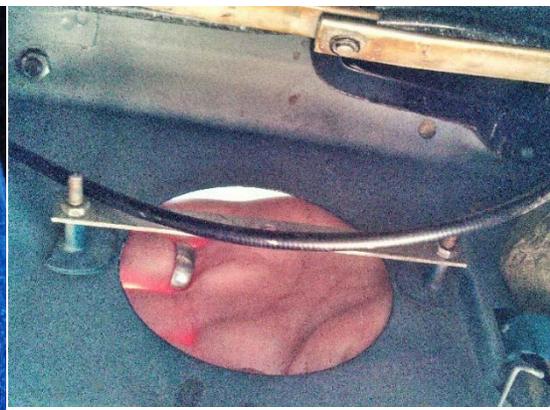
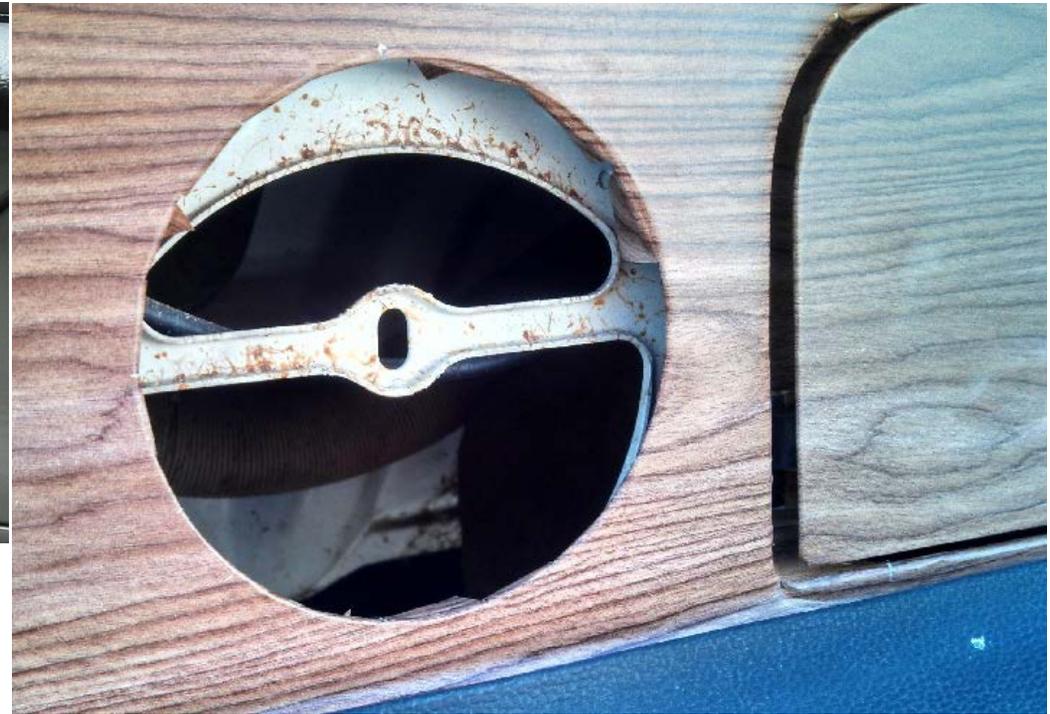
When installing the early style (below), fitted to T34s from 1962-66, there was a separate metal bar that slid over the two long studs behind the speaker hole. Two 7mm nuts secured the bar into place. Then a long machine screw went through the hole in the bar and secured into the speaker cover. You can see this installation from behind the dash (below).

When a new T34 was sold, if the buyer wanted a radio then it was installed as an accessory by the VW dealership. There was only one loudspeaker fitted to the T34s and it was always located in the gauge hole furthest from the driver. In front of the speaker was a cover plate that disguised the speaker from view and gave the dash a clean consistent appearance. This cover plate came in two styles over the years: early bronze (1962-66) & late silver (1966-69). The mounting hardware for cover plate also had two styles: added bar (1962-66) & built-in bar (1967-69).

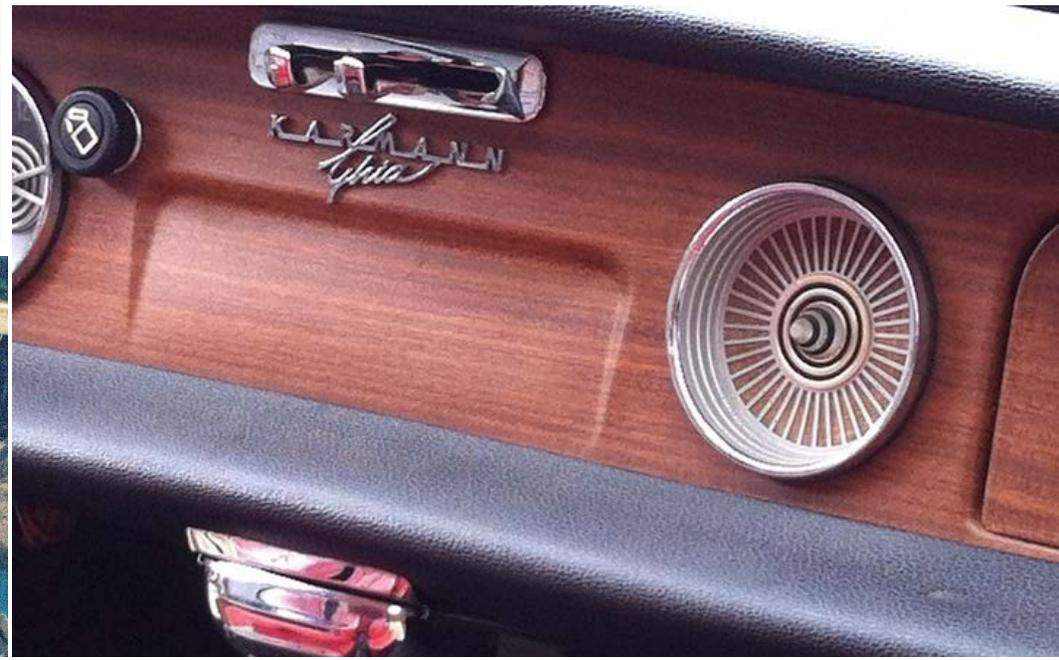
When installing the late style, fitted to T34s from 1967-69, the mounting bracket was already built-in (above), stamped with the new dash design along with the redesigned rectangular radio area. This allowed the speaker cover to be more quickly installed by simply screwing the machine screw into the cover.

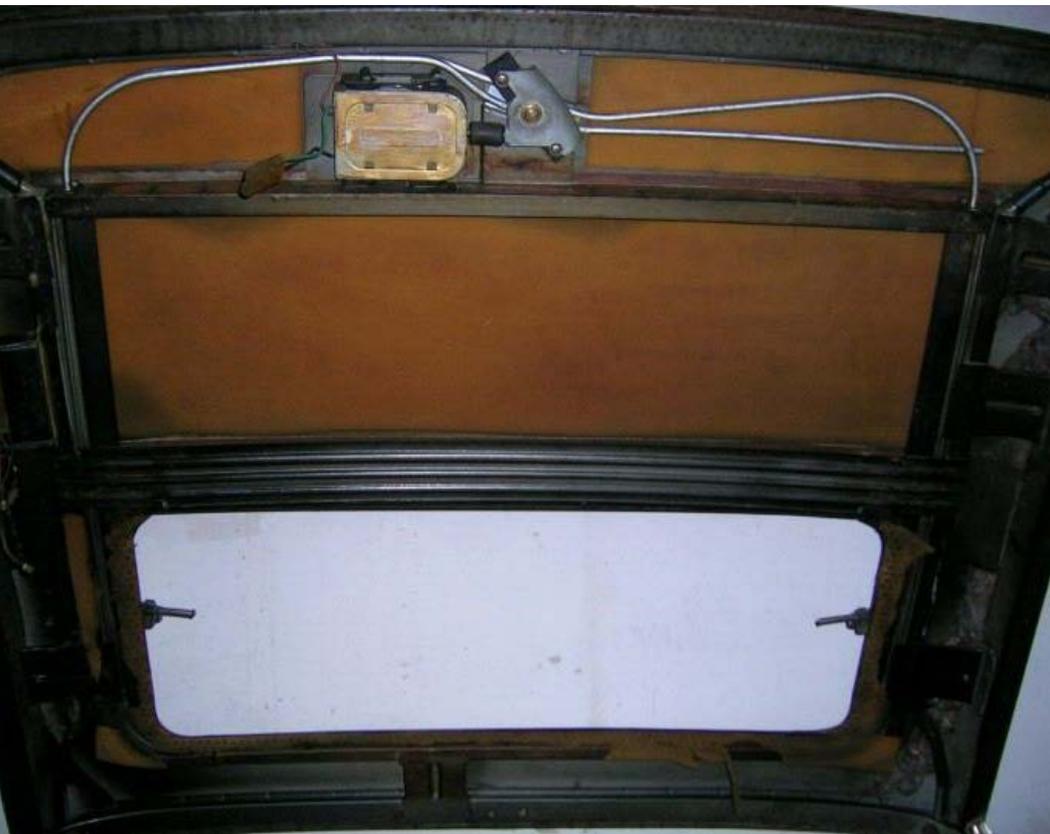
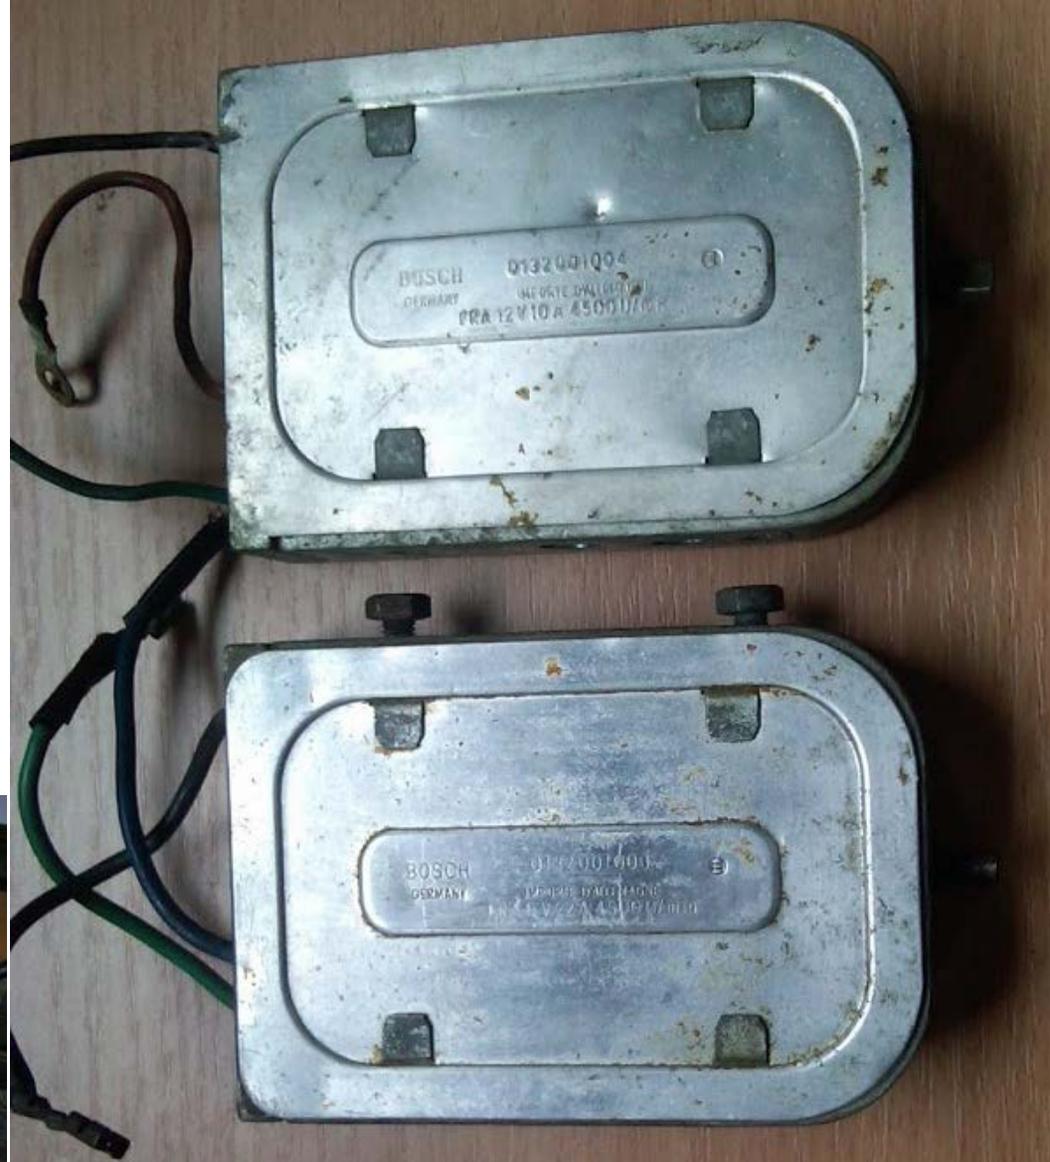
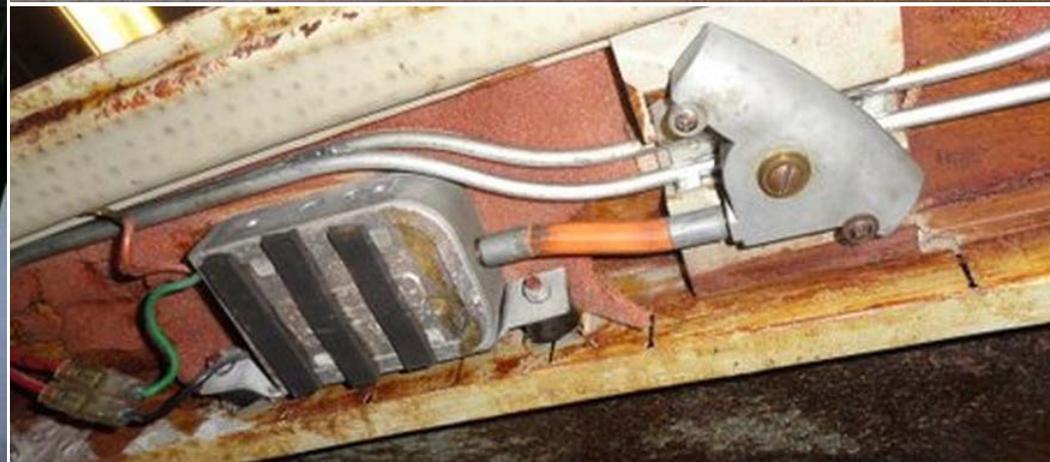
## Authenticity: Electric Sunroof Motors

The T34 was the second automobile to have been fitted with an electric sunroof (the Porsche 356 was the first) by Golde. Previous to that sunroofs were hand-cranked to open & close. The motor that operated the sunroof was built by Bosch and has part #0132001004. It was first offered as a 6V motor then in 12V as electric systems changed to 12V in the 1967 model year.

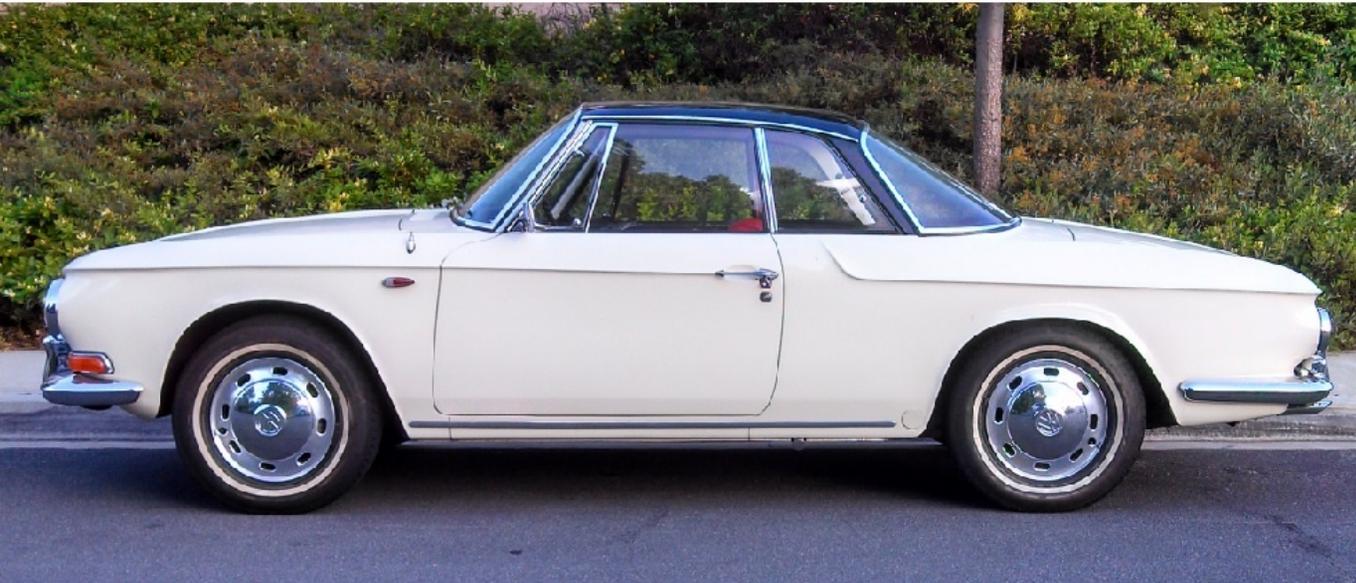
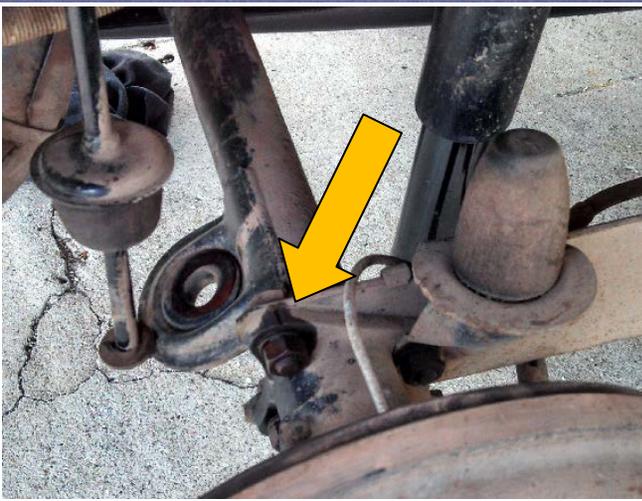
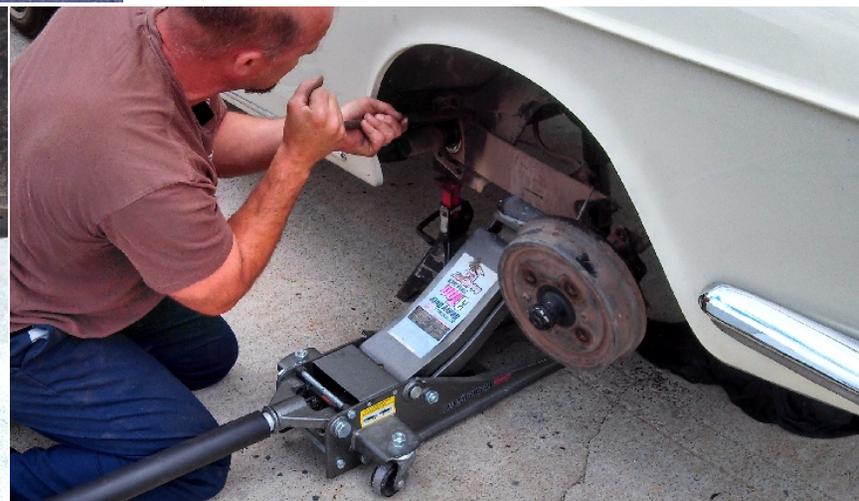
Below: the rear suspension three bolts get removed as well as the bump stopper (lower left). The front edge of the torsion housing plate drops down & gets marked before the housing cover is removed & the unit pulled-out & positioned down one spline (to raise the rear).

When we took a close look at the rear suspension we noticed the suspension components had never been adjusted, so the 1" lower height was due to typical sagging after 45 years of weight. But the front suspension had been adjusted by a previous owner. We also noticed the front bump stops (rubber stoppers designed to cushion the bottom-most travel of the shock absorbers) in the front had been cut in-half and prior to the adjustment there was only 1" of travel before hitting these stoppers. This was a poor attempt during the lowering process.

The rear was the most time-consuming process because the torsion plate was tough to break loose & tough to get the bolts back in. The front took only an hour. The front splines are easy to see (arrow) & adjust. I drove the T34 home and instantly felt a different (better) driving experience. No harsh bumps, just a smooth fine drive in comfort. The adjustments cost \$300 cash plus a 30-pack of Bud Light. The stock measurements set by the factory were: 25.75" (front) & 23.62" (rear).

Below: you can see the spline that gets adjusted. Once the parts are loosened-up then you simply pull-out the front arm, turn to the desired spline, and tighten everything back up again. I replaced the black rubber bump stoppers that had been previously cut in half. It's an afternoon's worth of work that most any mechanical owner can do with patience & a friend to help.
