# T34 World News

2014 Edition #31

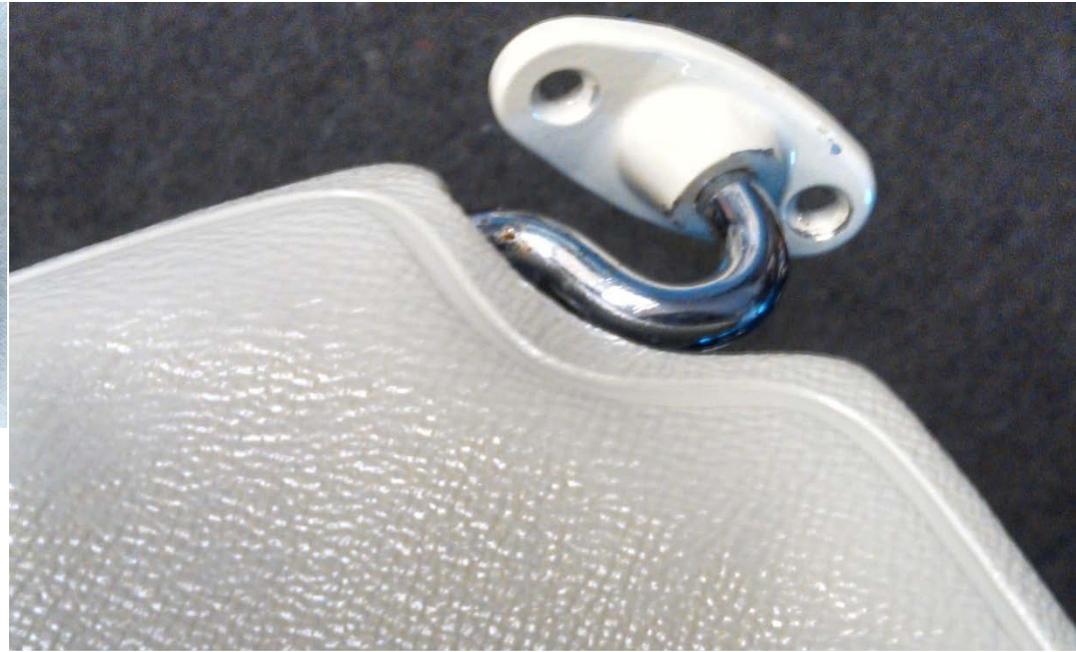
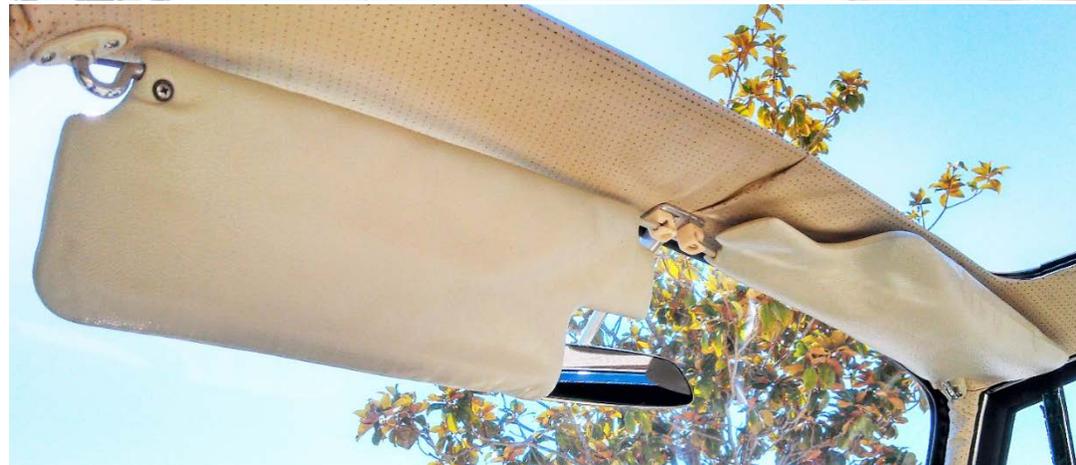
When the bases & screws are reassembled the results are fantastic! They look almost like new again and they're ready for another 50 years.

**DISASSEMBLY:** Once removed from the T34, unscrew the single Phillips screw holding the chrome arm onto the visor vinyl. Then rotate the sunvisor base 180 degrees until you're able to wiggle-out the chrome arm from the visor vinyl pad. If the plastic bases are broken remove the small cotter pin and replace them with the metal reproductions.

**CLEANING:** Run hot water and use dish soap & a scruffy 3M pad to clean the years of dirt & grime off the visors. Some of the stains will remain, which will easily be covered with paint. Lastly, if you have a passenger vanity mirror, mask it with painter's blue tape.

**PAINT:** Hang the visor pads outdoors by wires for an hour to allow the water to completely drain from the visors. For the painting process one thin coat of the spray paint was applied and allowed to sit for 15 minutes before relocating the visors into the garage for overnight drying.

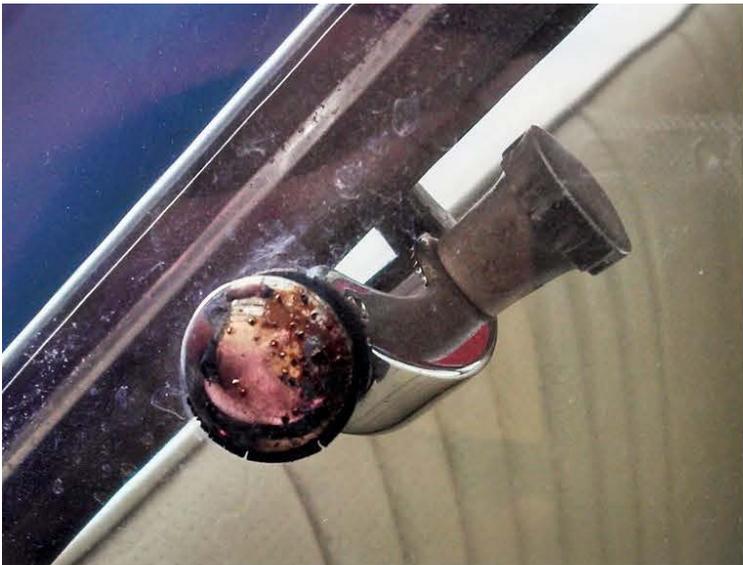
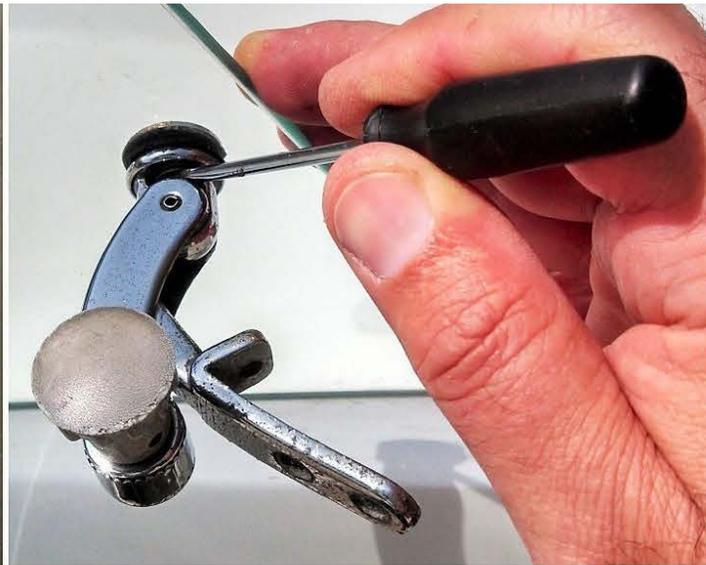
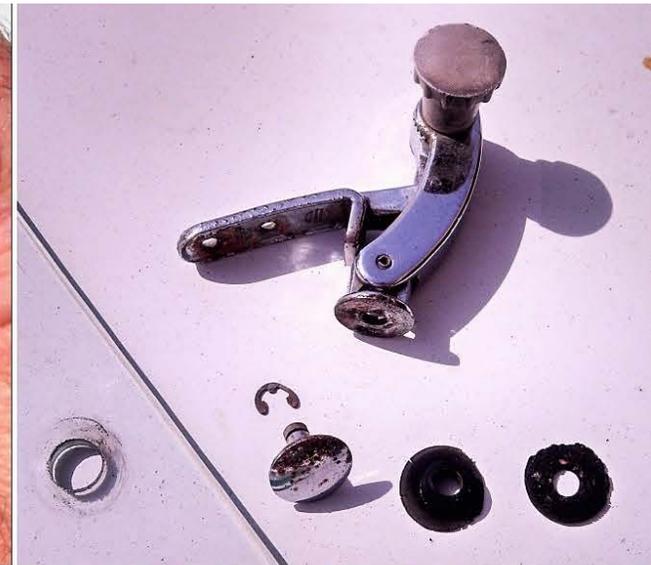
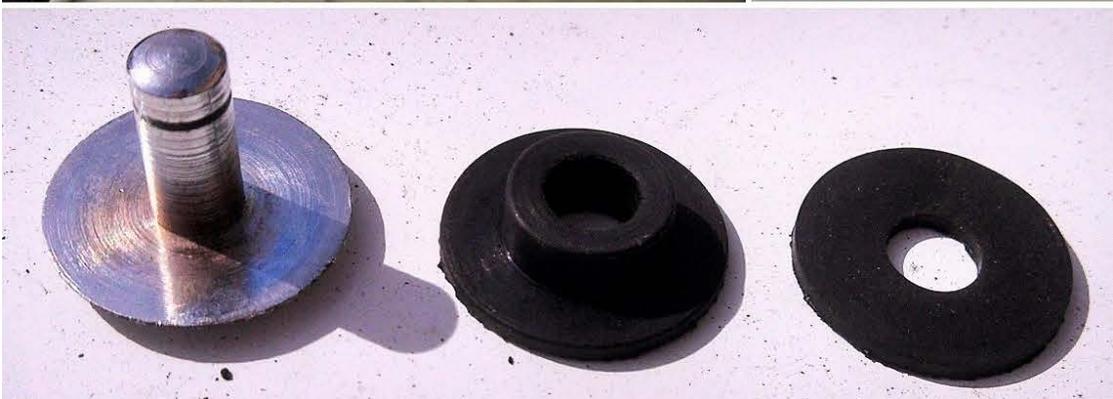
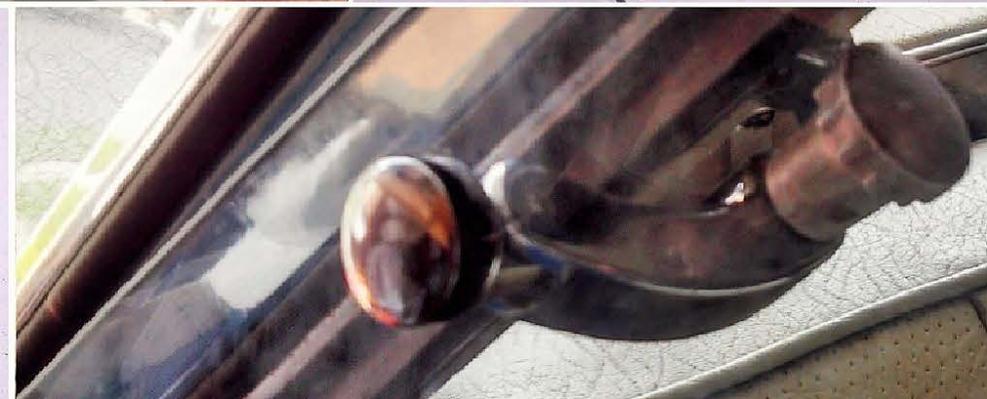
Above: KGP&R (or any KG parts supplier) offers the chrome buttons for about US\$5 and the two seals for US\$5/set to do both windows.

Use a tiny flathead screwdriver to remove the tiny C-clip just behind the chrome button. Take care not to lose this tiny part when it comes out. Remove the two black rubber seals on either side of the window as well as the rusty chrome button.

Reassemble the new parts and push the parts together hard to see the space where the C-clip goes back in for a snug fit. If you need to replace the B-pillar hinge blocks now is a good time to do that task as well. The whole process takes an hour to get right. But it's worth it when you can remove any signs of rust.

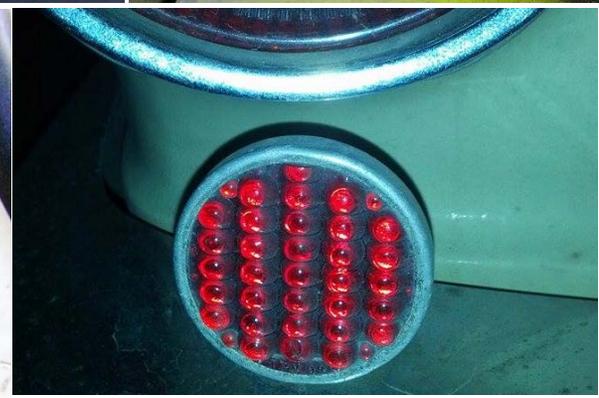
We found two styles among the rare French T34s. A horizontal 13-dot design (top pics) & a vertical 8-dot design (bottom right pic).

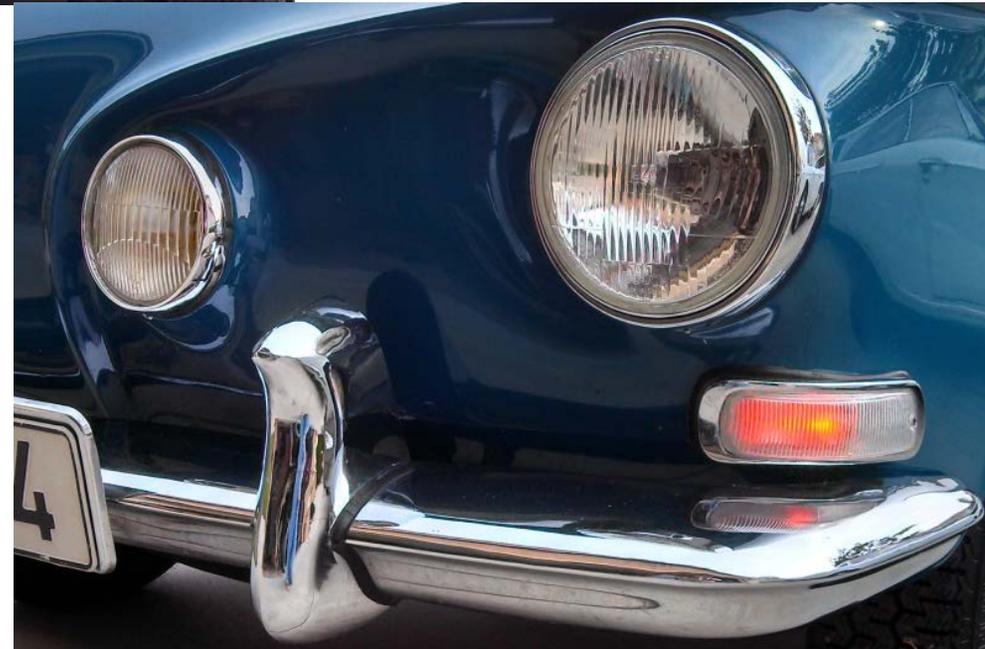
## Resto Tip: Amber Turn Signal Bulbs

Amber 6V single-pole turn signal bulbs are very difficult to find. But for \$5 you can buy hobby shop paint called Turn Signal Amber.

First use alcohol to clean the bulbs of all residue from your fingers. Then place them into a cardboard panel with only the bulb showing. Pour the paint into a small medicine cup (I used a Nyquil cup). Dip the bulb down into the paint until the paint covers the clear bulb. Hang the cardboard bulb-side down and allow the paint an hour to dry and then repeat the process for a second coat. Allow both to dry overnight and then install & test the amber bulbs. The look beautiful with the clear lens & inner amber bulb blinking away.

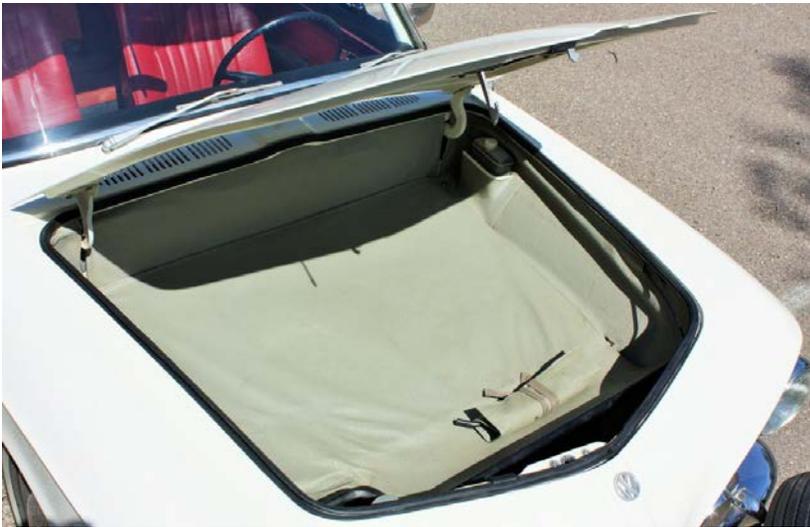
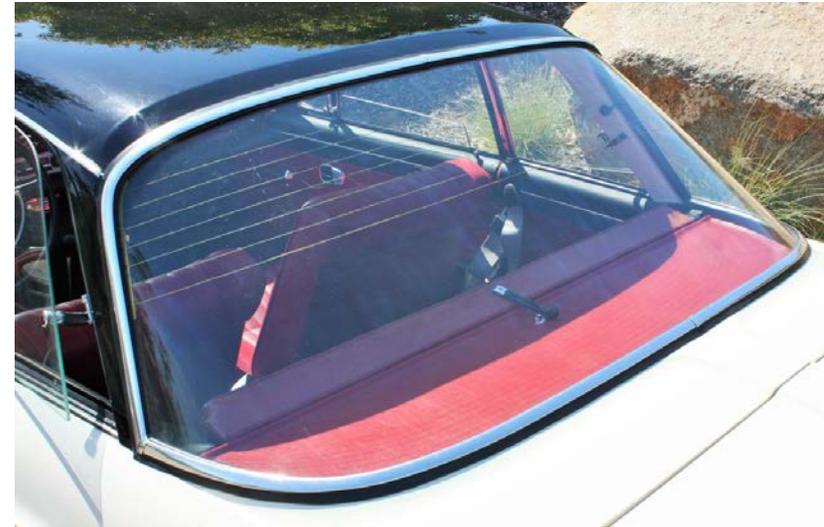
Beautifully original front compartment and rare M102 optional electrically-heated rear window. The Indian Red interior panels are original as is the Lava Gray carpeting. Under-dash parcel tray is always a useful accessory. The Lotus White & Black with Red interior is an outstanding color combination!
